Marlboro Tobacco Market, PG: 79-41C  
15301 Marlboro Pike, Upper Marlboro, MD  
1939  
Private

### Historic Properties Form

historic Marlboro Tobacco Market

street and number 15301 Marlboro Pike \_\_\_\_\_ not for publication

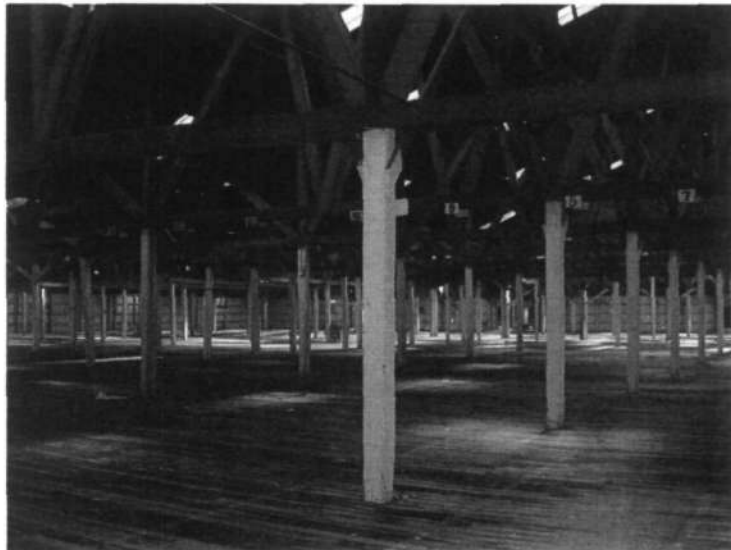
Photo 32:

The interior is mostly open; the south end of the market contains two rooms, divided from the main space by walls. A recessed loading dock (30.1' x 21.9') is located between them, and the roof over this loading dock has failed. The interior posts support trusses when they are located in areas under gable roofs. The posts have Y-shaped braces when they are located in areas under flat roofs. The floors are made from 2" x 6" virgin pine. The two parts of the rear wall measure 128.4' to the west of the loading dock and 98.6' to the east.

Detail of the roofing system of the main warehouse.

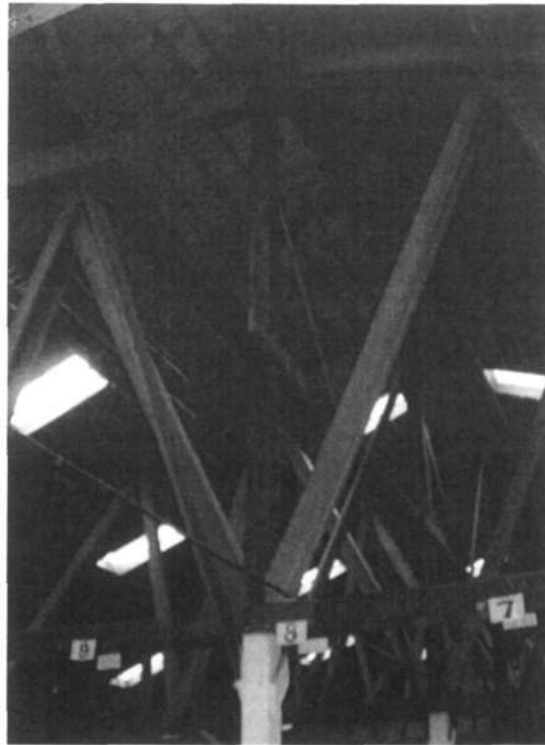
Photo 33:

The roof appears to be rubber-covered. The roof has enough skylights so that electric lighting is not needed in the interior during daylight hours. The skylights are made of Plexiglas. The peaks of the gable roofs have vents. Several sections of flat roof have failed and have caved in, breaking some of the cross beams.

Collapsed roof at the south end of the main warehouse.

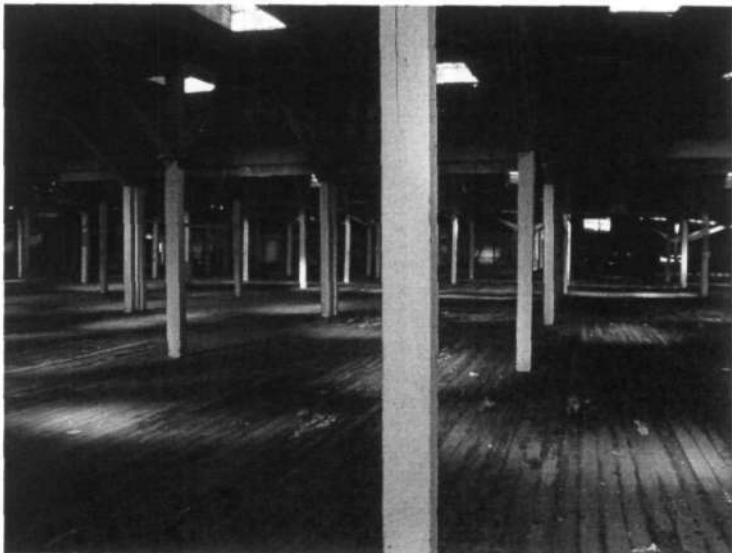
Photo 40:

Collapsed roof at the south end of the main warehouse.

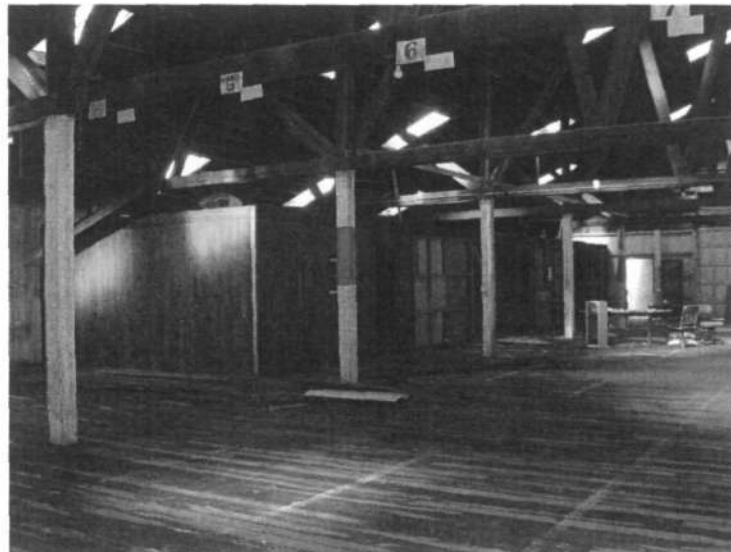
Photo 43:

Roof framing of main  
warehouse.
